# Field Measurements And Characterization Of A Sand Bed Stream For Riparian Rehabilitation And Modeling

Gorrick, Sam<sup>1</sup>, José F. Rodriguez<sup>1</sup> and Jetse Kalma<sup>1</sup>

<sup>1</sup>School of Engineering, University of Newcastle

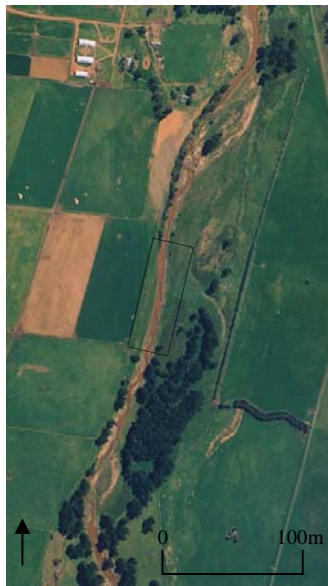
**Figure 2.** Aerial Photo of the Widden Brook and the field site

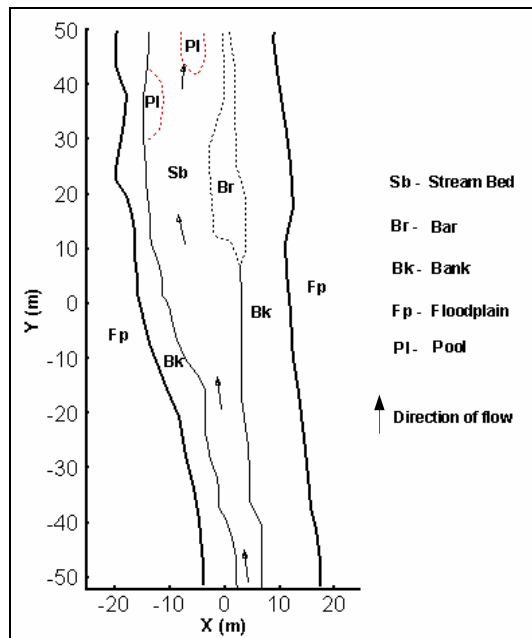
Before describing net sediment movement in response to the flood event some attention will be given to initial geomorphology and sediment mobility. Several important geomorphic units of the reach can be observed in Figure 3. Beginning upstream, the flow merges in a constriction before the active streambed widens and a bar diverts flow towards the left bank. This lateral bar (Brierley and Fryirs, 2005) is attached to the right bank and is a semi-permanent feature of the reach. In comparison, the bed configuration which includes the thalweg, dunes and other streambed features change periodically with flooding. The bar is positioned on the inside of a mild inflection while the outside bank exhibits a corresponding bend. A deep pool has formed where flow diverts from the bar to the left bank. Further downstream, flow converges into another deep pool before leaving the reach.

**Figure 3.** A reach scale planform map of important geomorphic units.

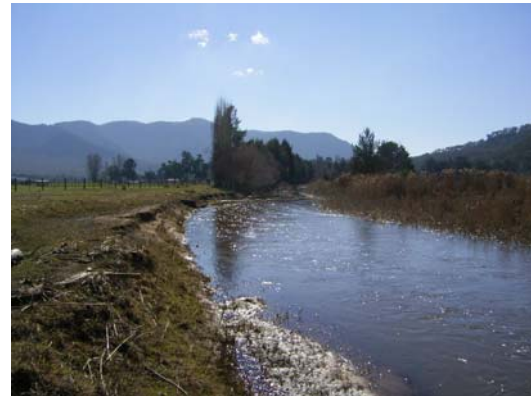
Existing riparian vegetation is quite sparse. In the middle ground of Plate 1 *Phragmites* a riparian reed, grows on the right bank. However these plants are seasonal and not flood resistant. Longstem tubestocks will be planted mainly along the bare left bank for rehabilitation and ongoing monitoring.

**Plate 1.** Field reach looking downstream. (Source: Gorrick, S).

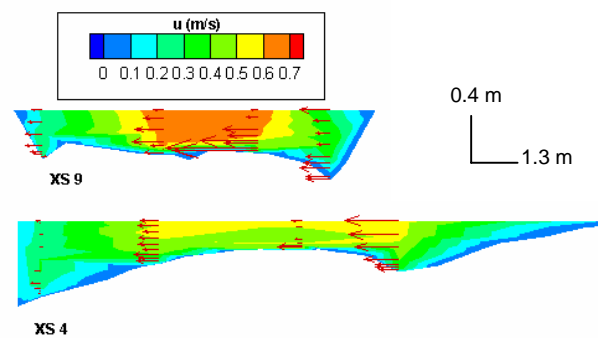
Flow velocity data was processed using the commercial WinADV software. Flow parameters including streamwise velocity ( $u$ ), spanwise velocity vectors and turbulent kinetic energy (TKE) were extracted. TKE represents the energy extracted from the flow by turbulent eddies. Together the parameters form a representation of the flow structure. Velocity results are presented in Figure 6, where contours represent streamwise velocity, and vectors represent spanwise velocity.

ADV measurements were quite unambiguous in identifying the direction of flow. At XS 9 and 4 spanwise velocity vectors are directed towards the left bank as controlled by channel curvature. At an inflection point between XS 4 and 1 the channel redirects flow towards the right bank. Further downstream at XS 1, the spanwise velocity component is directed towards the right bank.

**Figure 6.** Streamwise flow velocity and spanwise velocity vectors in XS 1, 4 and 9.

A smaller channel at XS 9 constricts flow resulting in higher streamwise velocity (Fig. 6). XS 4 has greater channel capacity and streamwise velocity is slower (Fig. 7). XS 1 contains a zone of high streamwise velocity in the central region of the channel bounded by two slow moving zones (Fig. 6). Turbulence at XS 9 is also high with maximum values of TKE twice that of XS 1 and 4 (Fig. 7). Unusually high TKE exists near the left bank (Fig. 7). A weak secondary circulation cell may partly explain the high turbulence. In XS 1 spanwise velocity vectors show a secondary circulation cell moving toward the left bank near the bed. The zone of maximum TKE occurs near the channel thalweg but is not particularly high (Fig. 7).

Some important inferences can be made on the relationship between geomorphic changes, flow structure and channel morphology at each cross section. Beginning upstream, XS 9 transects an area of extensive fill with relatively high velocity and turbulence fields. There is no doubt that extensive fill has occurred through large sediment influxes originating further upstream. High values of TKE, streamwise velocity, and strong spanwise velocity may indicate ongoing migration of bedload downstream. In addition the highest level of bed shear stress was recorded at XS 9 (9.2 Pa). Richards (1982) comments on short term adjustments made during flood events. He infers that incoming sediment cannot be carried through a reach all at once, instead it is deposited. In so doing channel capacity is reduced, increasing velocity and allowing more sediment to be carried through. Put another way high velocities would indicate a positive feedback to maintain sediment

Further downstream, scour and fill occur along the outside and inside bend respectively. At XS 4 flow goes around the lateral bar consistent with measurements showing small velocities, low turbulence and deposition. The streambed remains unchanged but this does not exclude mutual scour and fill processes associated with rising and falling stages of a flood event. Continuing downstream, flow is forced over the bar toward the opposite bank at all points in the flow. At bankfull discharge it is hypothesized that topographic steering of flow creates enough shear force to scour the opposite bank.
